CARVER-PIEDMONT AGRICULTURAL INSTITUTE FACILITY ASSESSMENT

SPECTRUM DESIGN P.C.
Plaza Suite 1
10 Church Avenue SE
Roanoke, VA 24011-2104
540.342.6001 PH | 540.342.6055 FAX
www.spectrumpc.com

DECEMBER 10, 2015
PROJECT NO. 15054

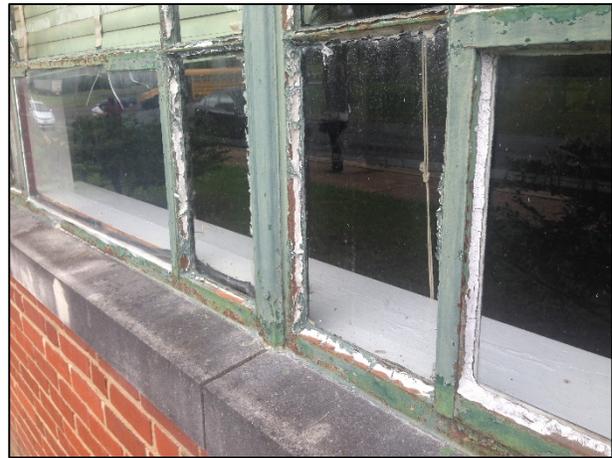
The windows are steel single glazed with operable awning/hopper sashes, typical of mid-20th century school construction. The glazing compound is in poor condition. There are many locations of window unit air conditioners installed in the window openings and in the brick below the windows. There are also many locations where the window openings have been bricked in, primarily on the back (east) façade.

Typical Window Glazing

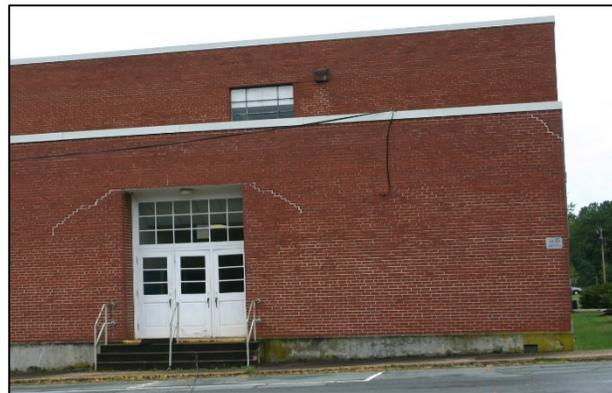
Repaired Brick at North Face of School

Past brick repairs can be seen in the north face of the school building. This repairs should be examined to determine if a suitable repair material was used, and the brick be repointed.

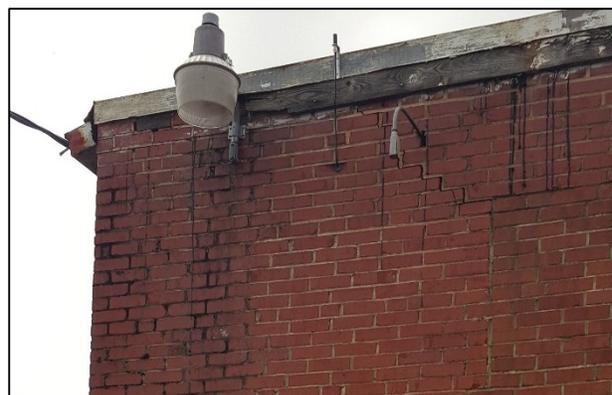
Brick at the Boiler Building is showing signs of age and possible water damage. And roof leaks or damage to the roof edge should be repaired to prevent further damage to the wall. The brick should be cleaned and repointed to prevent further damage.

Brick at Northeast Corner of Boiler Building

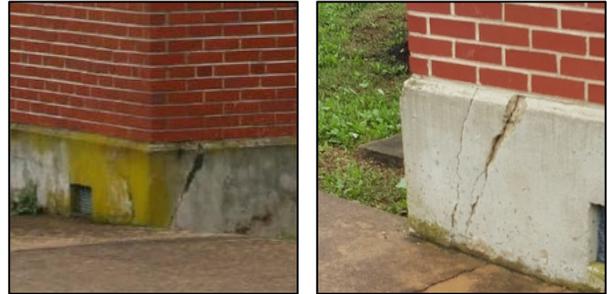
Cracks in the concrete foundation wall were present at many corners of the Main School Building. These cracks should be cleaned and injected with an epoxy crack filler to prevent water from entering the foundation walls and causing further damage.

Damage to Foundation Corners

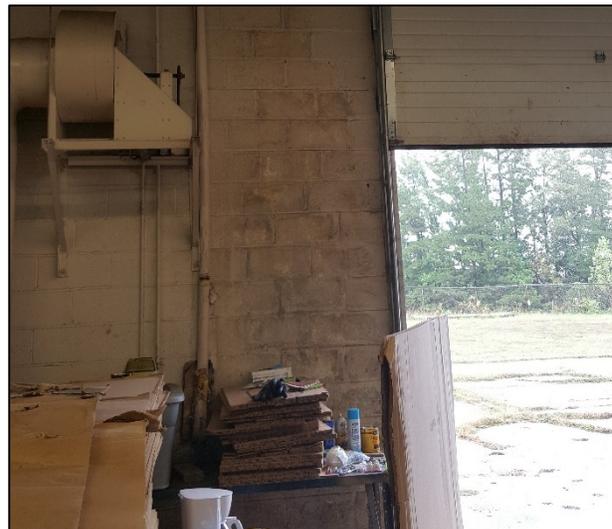
Water Damage At Interior CMU

Water damage on the interior of the concrete masonry walls is evident. This may be due to failure of the roof system.

In areas where the interior of the CMU walls have water damage, the roof system should be repaired to avoid further damage and the masonry cleaned and repainted

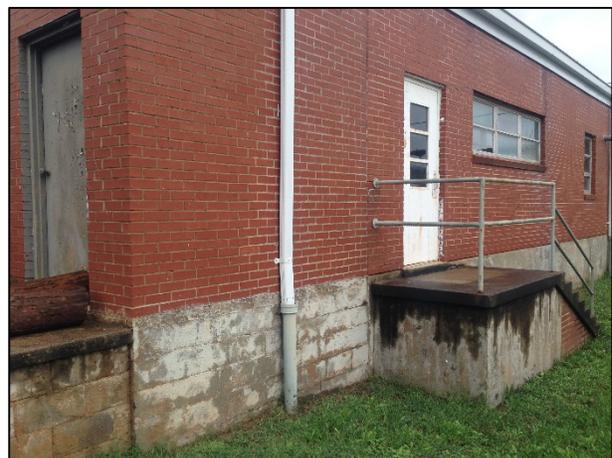
There are numerous deficiencies related to accessibility and compliance with the ADA Accessibility Guidelines. All exterior doors have steps. At minimum 50% of the entry doors should be adapted such that the egress path is accessible. This is achieved by providing ADA compliant ramps to grade and door hardware that is ADA compliant.

Non-ADA Compliant Egress

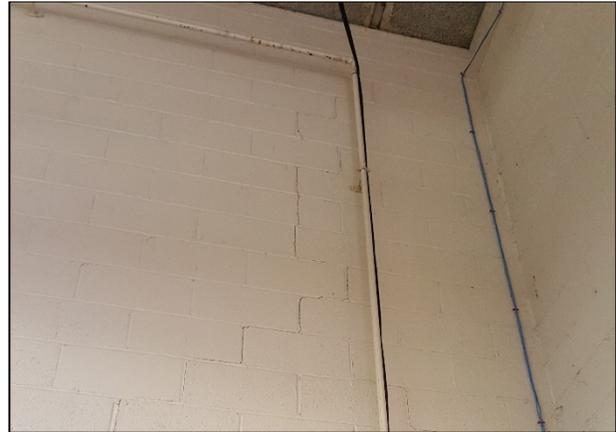
Extensive cracking and damage was observed in the Auto Mechanics area and west side of the building. Representatives present during Spectrum's site visit indicated the structural damage may not have been present prior to the earthquake in 2011 whose epicenter was in nearby Louisa County.

Cracking is observed in the interior face of the masonry walls in the Auto Mechanics area. Cracks appear in the corners of the walls, as well as along the length of the east and west walls, which are the short walls of the former gymnasium. The pattern and location of cracks are indicative of earthquake damage. The cracks in the short walls form an "x", indicating in-plane movement of the masonry wall. The structural failure of the masonry is extensive enough that repair of the walls is suggested.

Cracks in CMU walls at Auto Mechanics

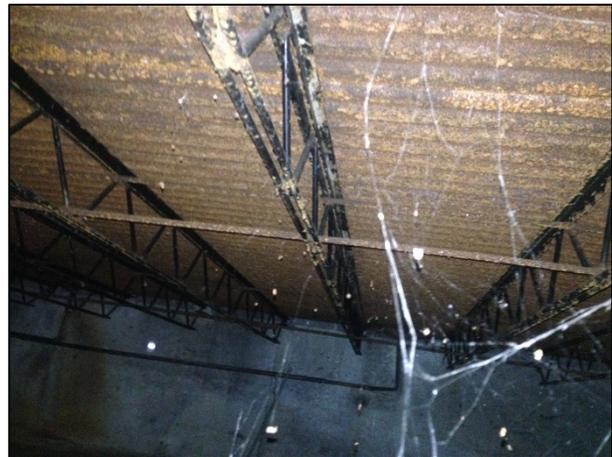
Framed Floor Above Fuel Room

The framed floor above the fuel room is constructed of steel bar joists supporting concrete slab on metal deck. The bar joists bear on the concrete foundation wall. The bar joists span in the north-south direction between the exterior wall and an interior CMU bearing wall between the fuel room and the boiler room.

This area of framed floor has dropped approximately one inch from its original location and a crack in the floor can be seen at the door to the exterior along the north side. Cracks in the walls and damage to the roof from the earthquake may be allows water to infiltrate the wall system. Water damage on the CMU near the location of the settlement may be causing degradation of the steel floor structure.

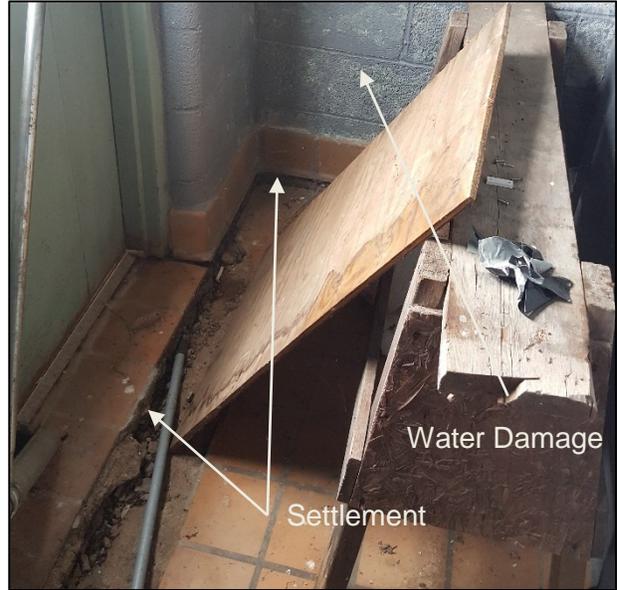
Settlement and Water Damage

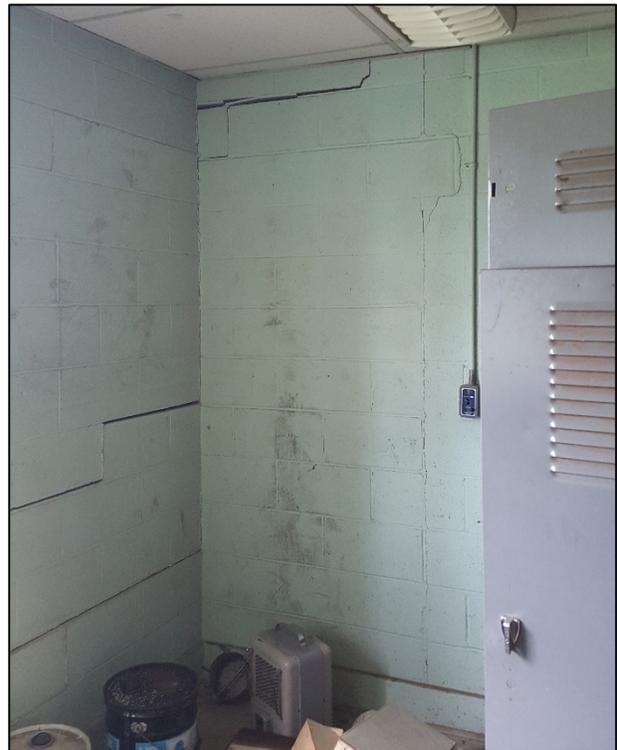
Extensive cracking can be seen in the walls of the locker room and boiler room. These horizontal cracks are indicative of movement of the wall out-of-plane. The size of the cracks indicates that the wall has been structurally compromised and requires repair.

Horizontal Cracks at Locker Room

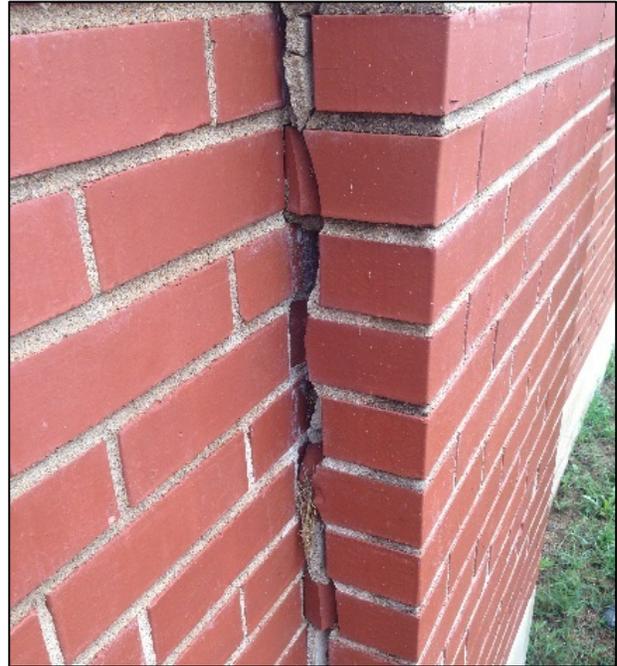
Cracks are evident at the pilasters, where the brick work is toothed into the wall. This cracking appears to also be from movement of the structure during an earthquake event.

Cracks at Brick Pilasters

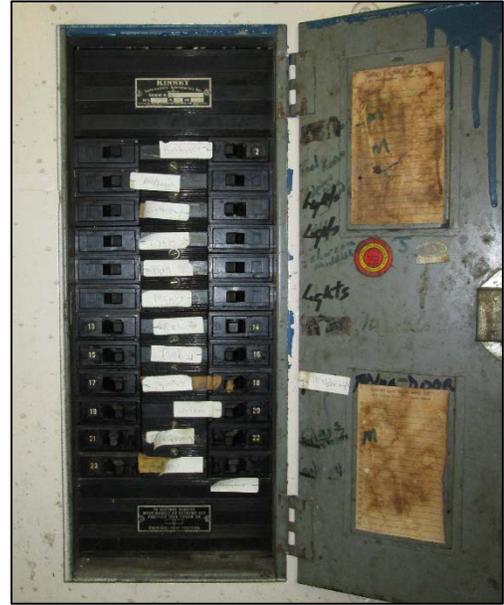
There are several other panels and load centers throughout the building of various ages, the oldest being a 200A Kinney panel that appears to be original to the structure. None of these panels are modern, and all would need to be replaced.

Obsolete Panel

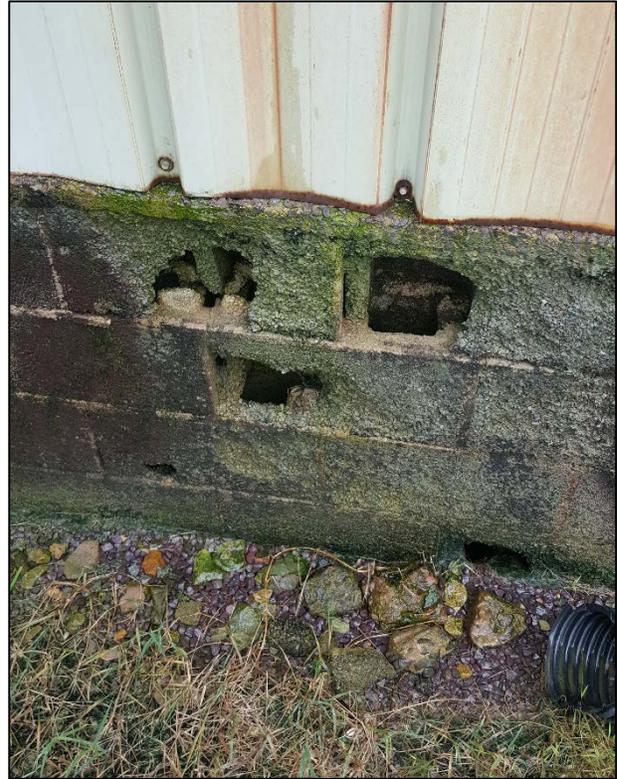
Building B Foundation Damage

In order to utilize Building B, it is necessary that the foundation walls be repaired. Downspouts should be directed away from the building and the site around the building should be re-grading so that water drains away from the building foundations.

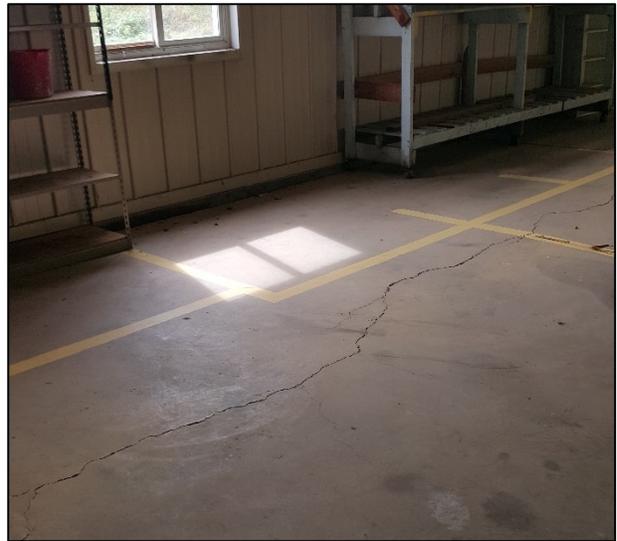
Some settlement of the slab-on-grade or foundation wall has occurred on the east side of the building. A crack has formed parallel to the east wall and the slab slopes down from the crack to the exterior wall. If Building C is renovated for future use, it is recommended that the subgrade below the settled area of slab be further investigated to determine if it is sound and repaired if necessary.

Settlement of the Slab-on-Grade

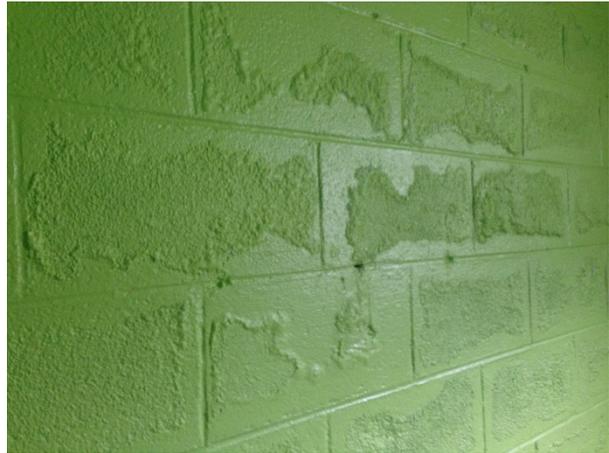
The structural members in Building D appear sound. No damage was noted in metal building frames or purlins. The condition of wall and roof panels is noted in the architectural section. Masonry walls in the west portion of the building are showing signs of water damage.

CMU Damaged by Water

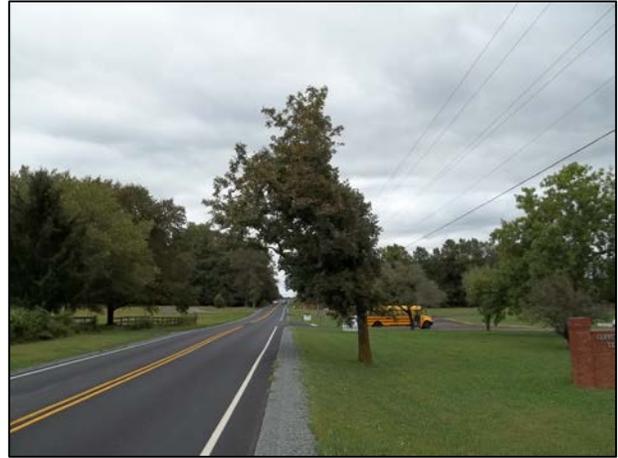
Leaning Tree
