CARVER-PIEDMONT AGRICULTURAL INSTITUTE FACILITY ASSESSMENT

SPECTRUM DESIGN P.C.
Plaza Suite 1
10 Church Avenue SE
Roanoke, VA 24011-2104
540.342.6001 PH | 540.342.6055 FAX
www.spectrumpc.com

DECEMBER 10, 2015
PROJECT NO. 15054

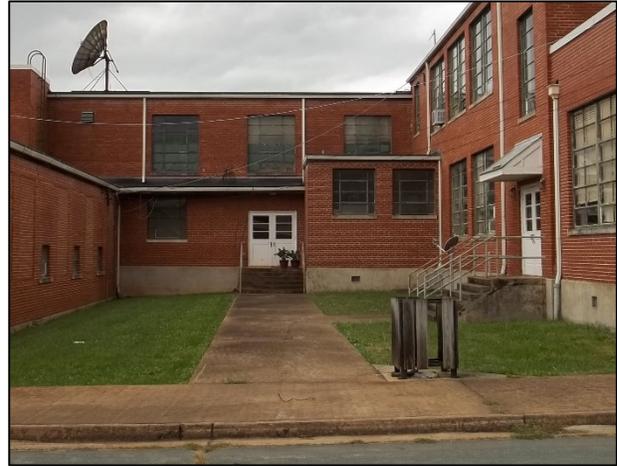
The main entrance is at grade but the majority of other doors have steps. ADA requires that an accessible route be provided at exits required for egress. Ramps would be required at some exterior exits to comply with this regulation. The existing wooden ramp at the south Cafeteria entrance which is in poor condition and does not comply with the ADA.

Typical Building Access Points

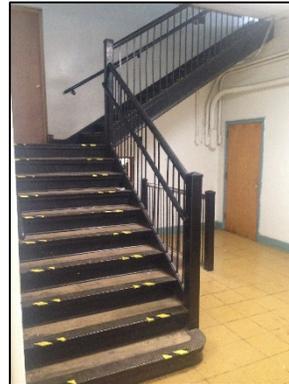
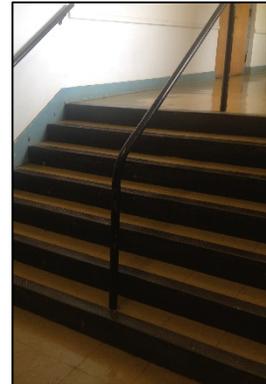
At each side of the auditorium there are two half-flight stairs in the corridor leading down to the former cafeteria and carpentry shop level. In addition there are two open stairs accessing the second floor classrooms behind the auditorium. The stair treads are vinyl tile, possibly asbestos containing, with a metal nosing. The existing handrails do not meet current code and ADA requirements for handrails and guardrails. All railing at stairs and ramps must have ADA compliant handrails. Modification to railings should include 12-inch extensions at all landing on both sides of the stairs. Any stair guard rail shall not have an opening of more than 4 inches.

Non-ADA Compliant Rails

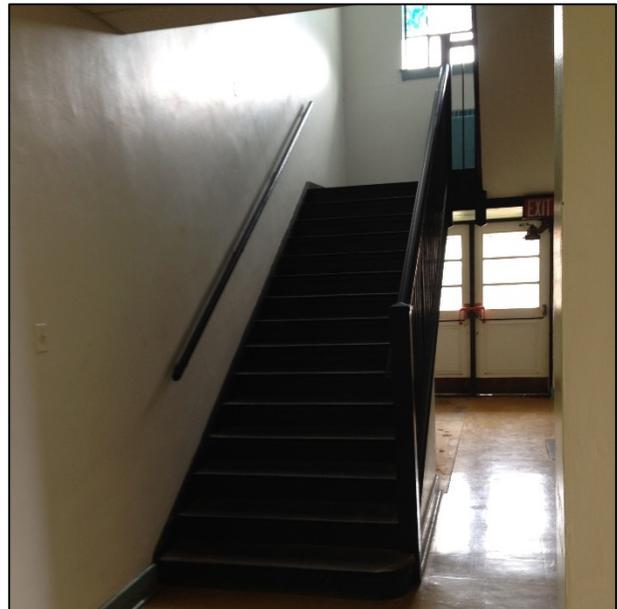
Typical Stair Open to the Corridor

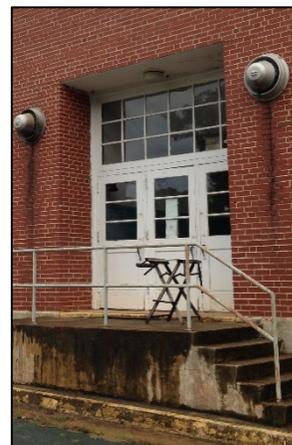
Exterior doors are half-glazed wood panel doors in wood frames with glass transoms above. The doors are in functional condition, with much wear and damage from weathering. Most hardware appears to be original. Most hardware sets appear to be functional, but do not comply with the ADA. The “egress bar” hardware at most exterior doors are the type that could be chained shut, and are therefore not recommended to remain in place.

Typical Exterior Door

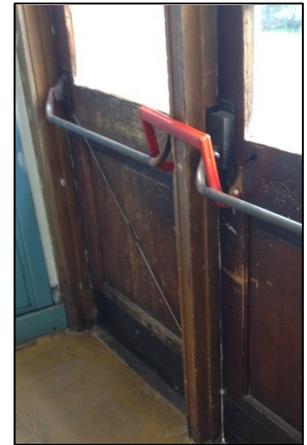
Typical Door Hardware

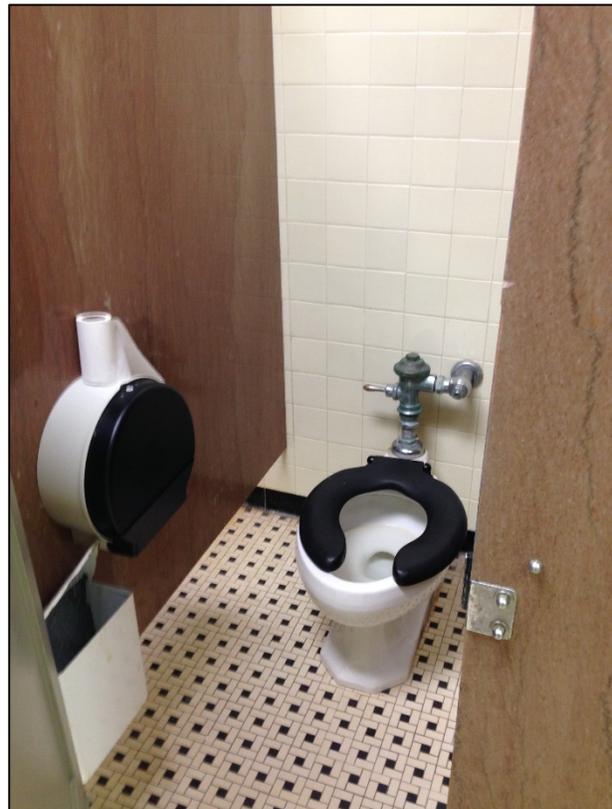
The public restrooms have ceramic tile walls, mosaic tile floor, marble stall partitions, and plaster ceilings. The restrooms are not accessible per the ADA. Accessibility deficiencies were observed related to fixture height, clear floor areas, stall size and configuration, and grab bars. There are also several smaller individual restrooms which are not ADA compliant due to door size, fixture height, and clearances.

Typical Toilet and Toilet Partitions

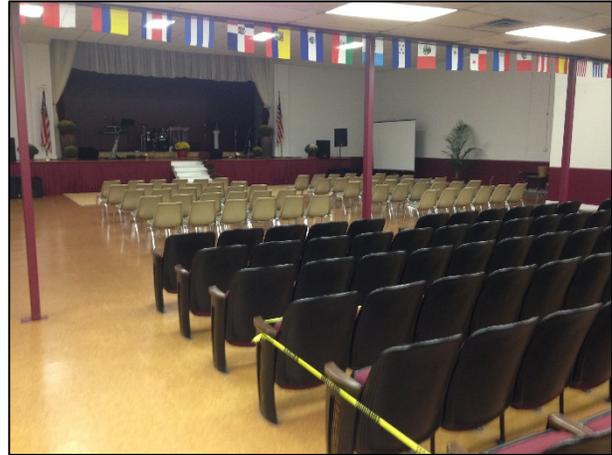
The Gym / Auditorium has a flat floor and a portion of the room has a double height ceiling. There is fixed theatre seating under the lower ceiling area in the back of the room. The flooring is VCT, walls are painted CMU, and the ceiling is 2 x 4 lay in tile. The finishes are serviceable. An elevated stage is accessed from the auditorium by portable stair risers. The risers are not code compliant since they have no handrails. There is no ADA accessibility to the stage.

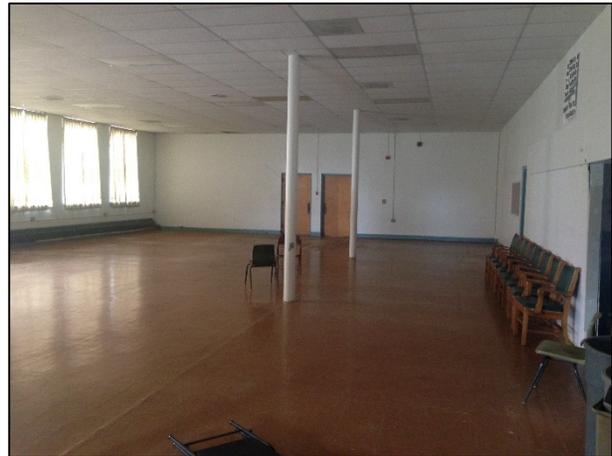
The Cafeteria is a large high ceiling space. The flooring is VCT, walls are plaster, and the ceiling is 2 x 4 lay in tile. The finishes are worn but the space is serviceable. There is not an accessible route to the Cafeteria from the building's interior due to the stairs at the interior corridor. The accessible entrance from the exterior (south) will require replacement of the existing wooden ramp with ADA compliant entry.

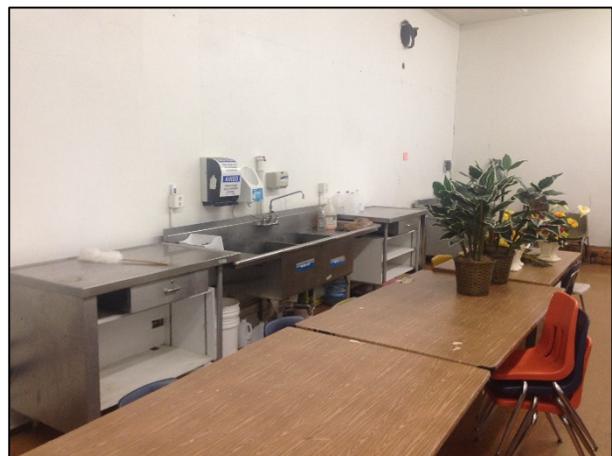
The Kitchen is also finished with plaster walls, VCT floor, and lay in ceiling. These materials are not ideal to meet current health requirements. Replacement of finishes to materials that are nonporous and scrub-able may be required if food production exists in the future. There is no dedicated hand wash sink in the kitchen. One must be added to meet health requirements. The dish sink is a two-compartment type, which would need to be replaced with a three-compartment sink to meet current health department requirements. There is an electric griddle which does not have a hood. If this equipment is to be used in the future it will require a commercial kitchen hood with fire suppression.

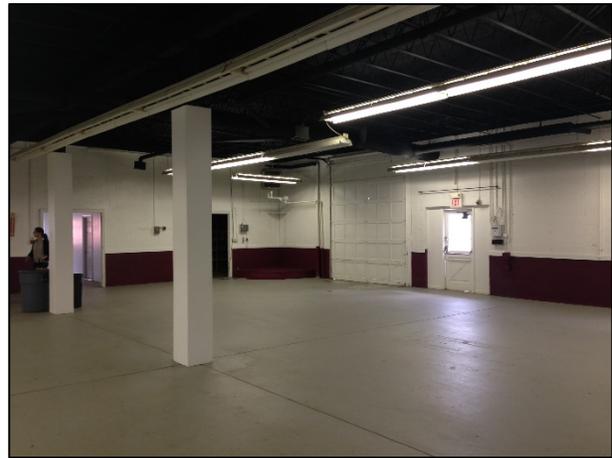
The former Carpentry Shop is a large high ceiling space with a row of columns in the center of the room. The floor is concrete, the walls are painted CMU, and the ceiling is exposed bar joists and cement fiber deck (Tectum). The space access from the corridor adjacent to the Auditorium and directly from the outside by doors at the north and an overhead door to the east. This space could easily lend itself to the proposed agricultural/food uses. Depending of the ultimate use, upgrades to floor and wall finishes, and the addition of plumbing, ventilation, power and lighting will be required to meet USDA and state health department requirements.

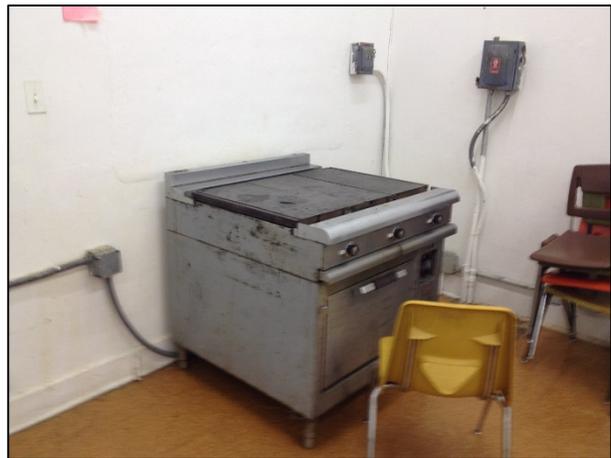
The existing kitchen contains a commercial type electric flat-top griddle/oven. However, there is no exhaust hood, and therefore should not be used for cooking. The mechanical code requires a Type I grease exhaust hood for cooking appliances that produce grease or smoke, or a Type II hood for appliances that produce heat or moisture. Should the Authority Having Jurisdiction rule that neither a Type I or Type II hood is required, the code would still require an operable exhaust providing 0.7 cfm per square foot of kitchen space. It is noted that there once was a working exhaust fan above the oven.

Commercial Griddle/Oven

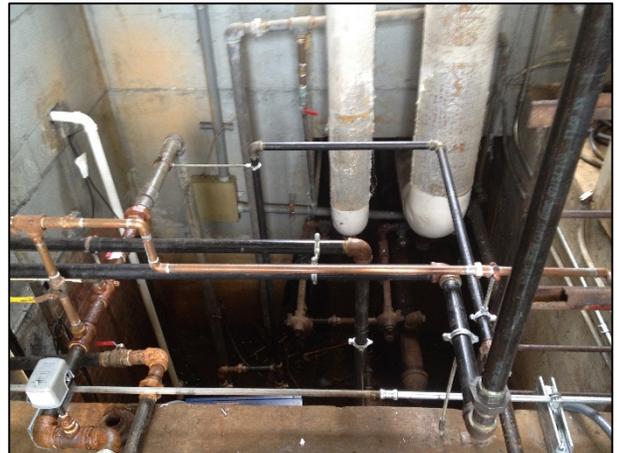
Steam Pit

The steam pit has two small leaks in the foundation, which were noticeable due to the large amount of rain that had occurred in the days preceding the field investigation. The leaking water collected in the bottom of the pit, where it was pumped out from the duplex sump pumps located in the bottom of the pit.

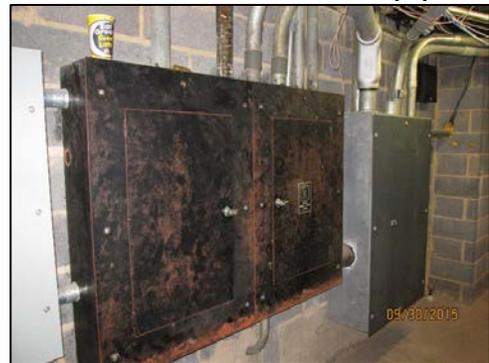
Old Main Service

The new distribution system feeds primarily the classroom wings, and is assumed to serve the lighting and receptacles in these areas (the panels are not marked). The legacy distribution system appears to feed the auditorium, shops, cafeteria, and other auxiliary spaces in the rear wing of the building. The panels in the shops, auditorium, and cafeteria are either original or of older vintage, and are obsolete and past their useful service lives.

The legacy distribution systems in the building are largely original, and have reached the end of their useful lives. The new switchboard and panel network is modern and is in very good condition.

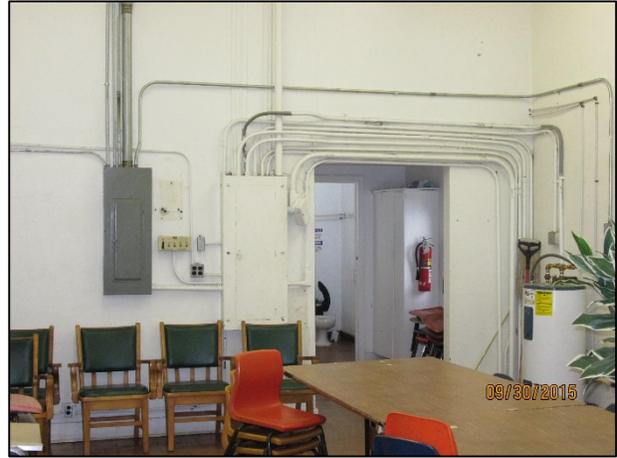
Cafeteria Panels

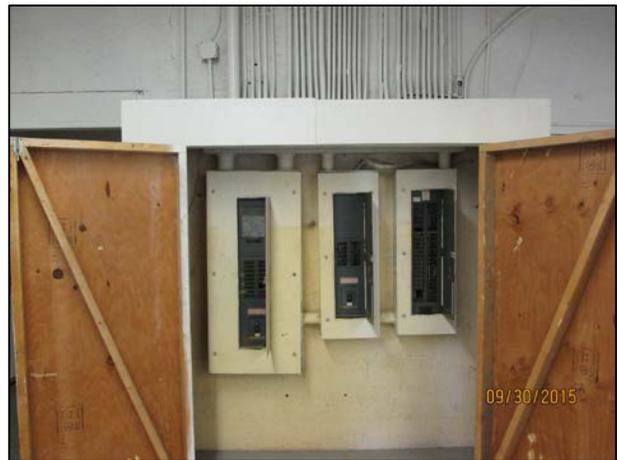
Old Shop Panels

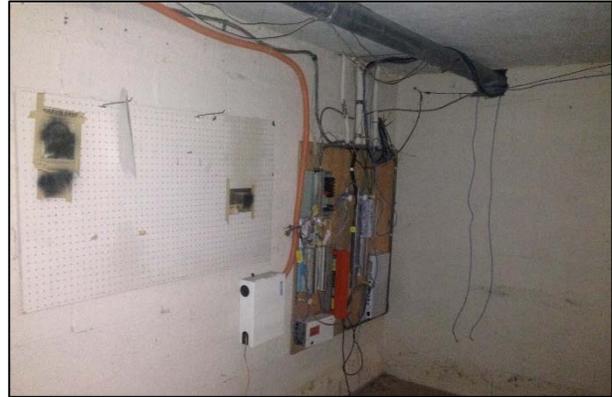
The building is equipped with apparently operable telephone systems, however the main telephone backboard show a lot of out of service equipment and wiring. It is unlikely that the existing systems would support any major upgrades in the facility requiring modern communications equipment.

Existing Telephone Backboard

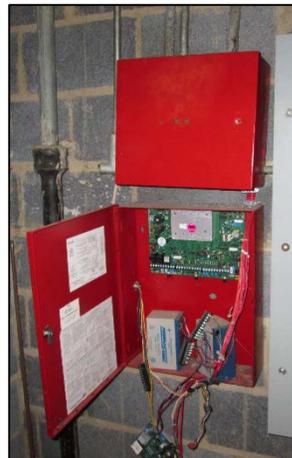
The building is equipped with a complete, but older, fire alarm system consisting of pull stations and horn/strobe notification devices. The main FACP, a First Alert non-addressable system, appears to be non-operational, as it has internal components disconnected. It does not appear that the system is set up to dial a central station, but acts as a stand-alone fire alarm.

Fire Alarm Control Panel

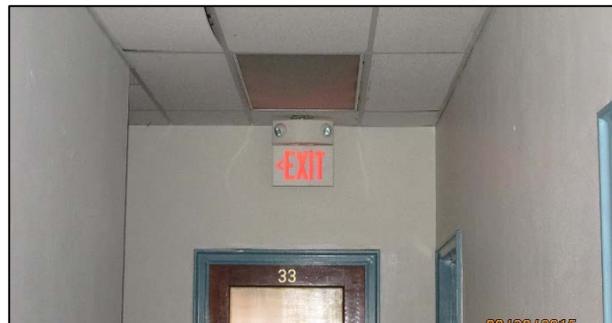
The building is equipped with modern battery-powered combination exit sign / emergency lights throughout egress paths. There are some minor parts of the facility that are not completely covered with exist signs and egress lighting.

There is no exit discharge lighting installed.

Emergency Exit Light

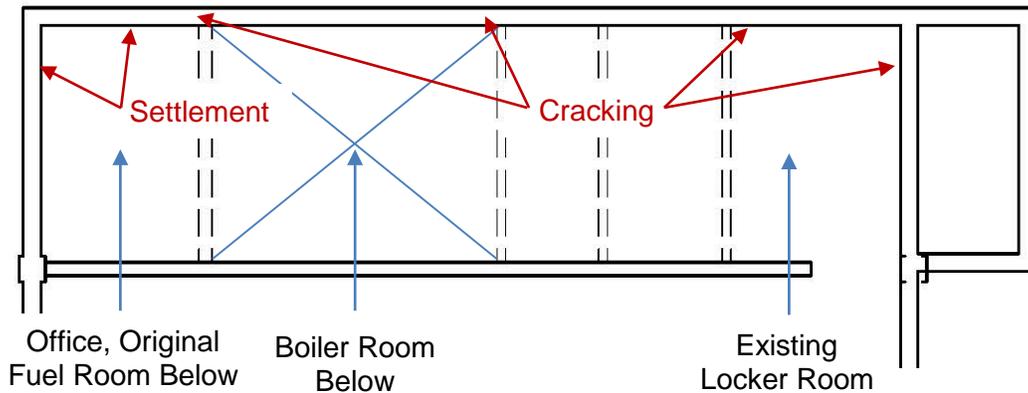
Plan, East End of Building A

Cracking and settlement is also evident in the east area of the building. The plan below shows the spaces in the east area with labels for discussion.

This area of framed floor has dropped approximately one inch from its original location and a crack in the floor can be seen at the door to the exterior along the north side. Cracks in the walls and damage to the roof from the earthquake may be allows water to infiltrate the wall system. Water damage on the CMU near the location of the settlement may be causing degradation of the steel floor structure.

Extensive cracking can be seen in the walls of the locker room and boiler room. These horizontal cracks are indicative of movement of the wall out-of-plane. The size of the cracks indicates that the wall has been structurally compromised and requires repair.

The exterior and interior walls on the west sides of the building that are showing horizontal cracking are not structurally sound. The walls have been compromised to the extent that their replacement may be required. These areas of the building should be removed and replaced with reinforced masonry construction to meet the current building code.

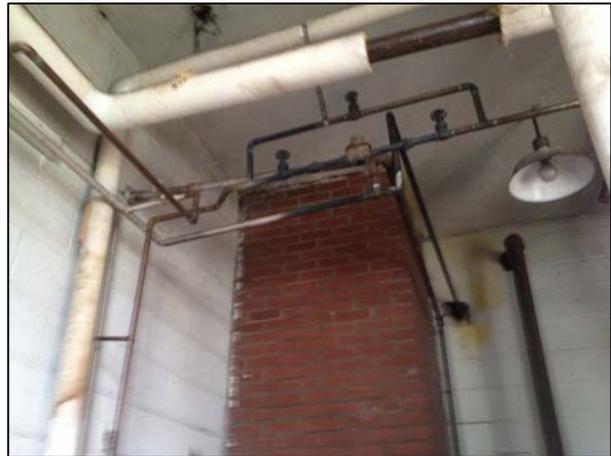
Except in the localized area of the valve failure, the piping and insulation appear to be in fair to good condition. However, one of the maintenance personnel said that the condensate receiver seems to be too small because the system seems to use a lot of make-up water. From an engineering perspective, it is not clear as to why this would be true. The condensate receiver serves only the steam system in Building A, whereas the hot water portion of the boiler serves Building B. If it is true that the system uses a lot of make-up water, it should be assumed that the system has a leak at some location, be it in Building A or in Building B, or in the piping between the two buildings.

Existing Piping and Valves

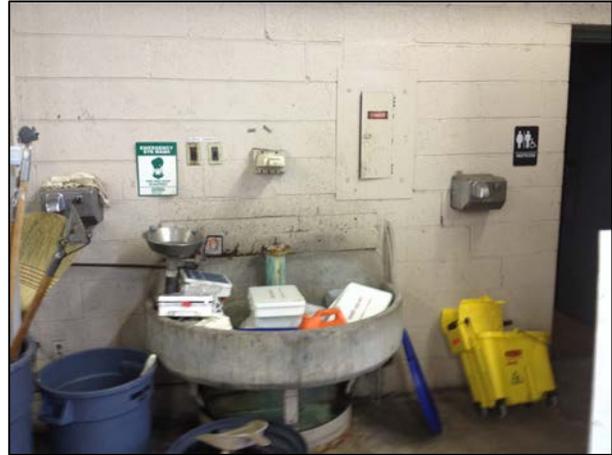
Out of Date Plumbing Fixtures

All plumbing fixtures in the building need to be replaced.

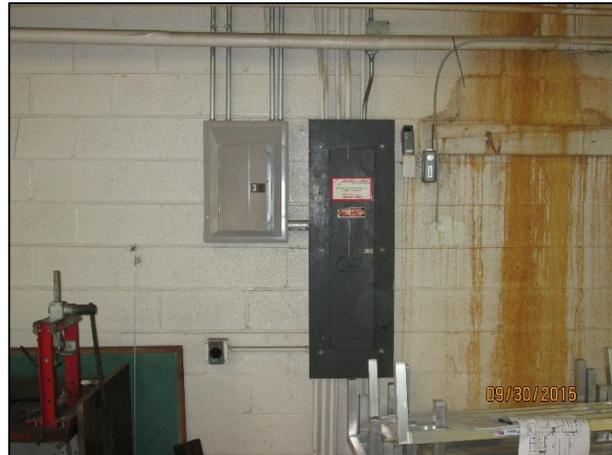
The main service to the building is 225A at 208/120V. The service originates at a utility pole to the south of the building, and is connected to a service mast on the east side of the structure with aerial triplex cable. The main service panel is an older GE NLAB style panel. This panel is beyond its useful life, and would need to be replaced if the building is to be re-purposed.

Main Service Disconnect

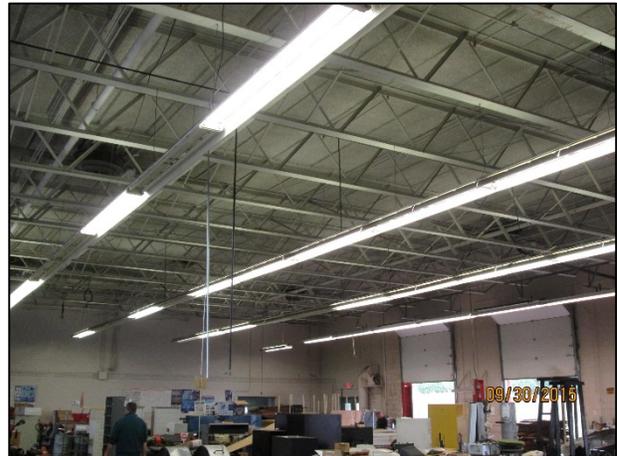
The majority of the building is equipped with 8' linear 2-tube T12 fluorescent fixtures. These are mounted using various methods including chain hung, stem hung, and surface mount. These fixtures are obsolete, and are no longer specified due to energy efficiency. The fixtures do appear to be largely in working order, and could be used, though it is recommended to replace the entire lighting system in a remodeling project.

Fluorescent Lighting

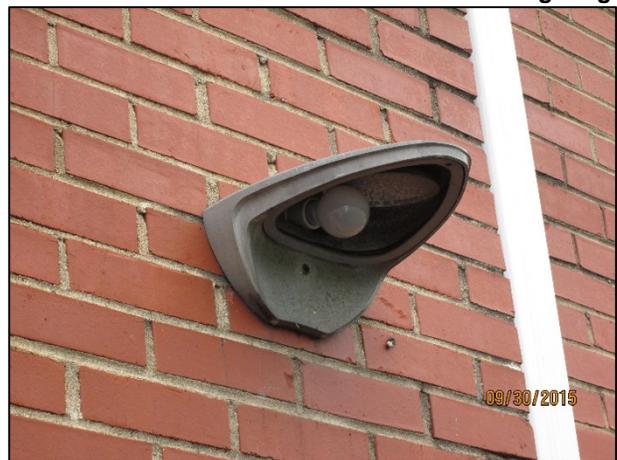
Exterior lighting is scarce, and consists of several incandescent wall fixtures and one mercury vapor area light mounted to the building above the garage doors. All fixtures are vintage and in poor condition. These would be recommended for replacement and enhancement in a remodeling effort.

Outdoor Light Fixture

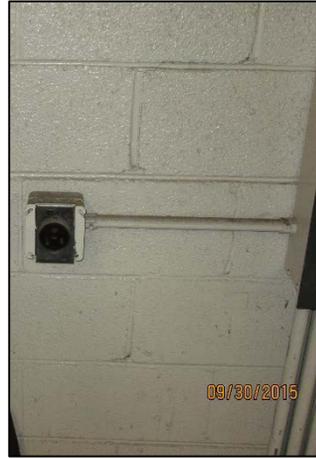
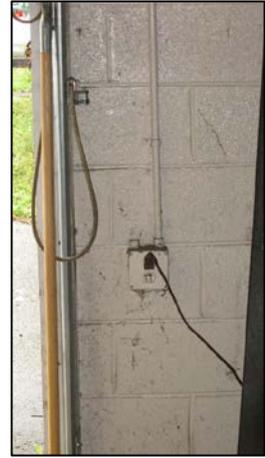
Wiring and wiring devices within the building appear to be largely original, and appear to be in working order. Any reconfiguration of the facility would require a great deal of modification to the systems and in light of their age, it is recommended that all wiring and devices be replaced.

Existing Wiring

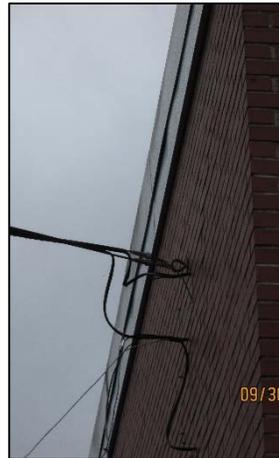
The building has an aerial telephone drop that originates at a utility pole to the south of the structure. This service appears to be a small pair count, and is of original vintage. There is no apparent data connection to the structure. Data and telephone systems would need to be completely replaced in order to provide modern services to the facility.

Telephone Drop

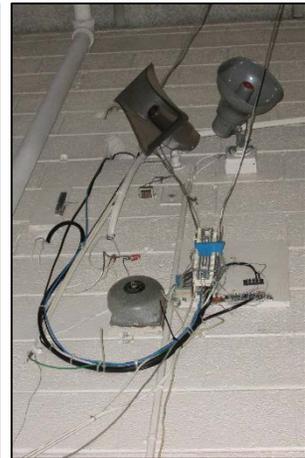
There is an old intercom and bell system evident in the building, however it appears to be in non-working condition.

Intercom and Alarm Bell

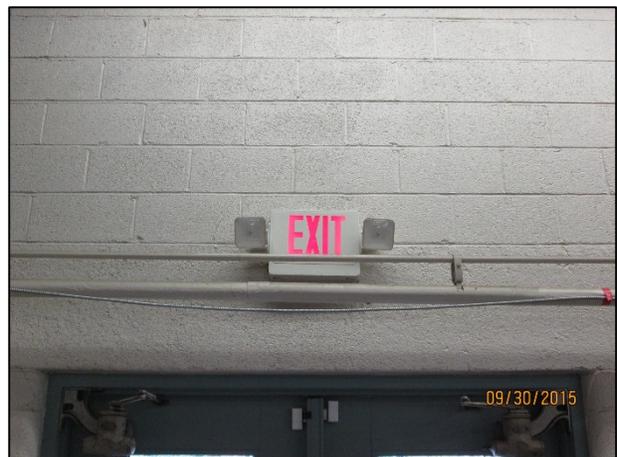
There are modern battery powered combination exit light / emergency light fixtures in the building in the correct locations. There is no exit discharge lighting installed.

Emergency Exit Signs

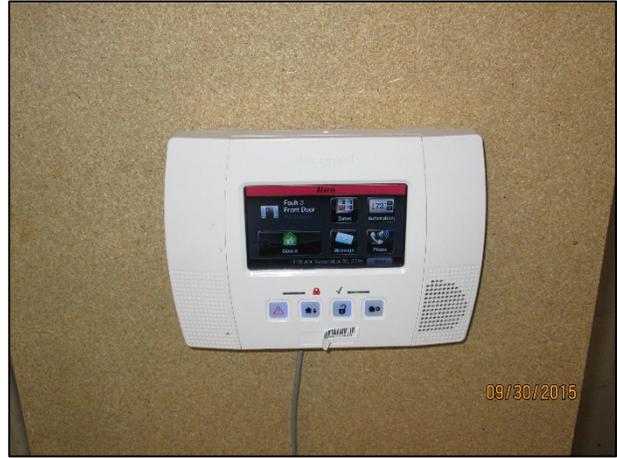
There is no fire alarm system in the building. The current use of the structure is police evidence storage. As such, there is a modern Honeywell security system installed. This system is a typical wireless residential-grade system with wireless motion sensors and door switches. The system is connected to a monitored alarm center by telephone.

Security System

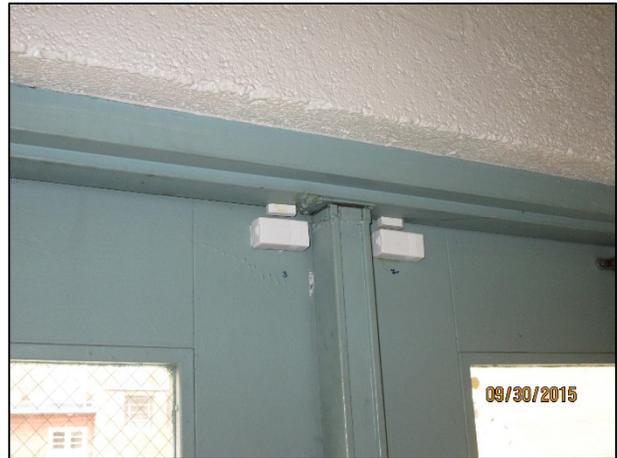
Door Sensors

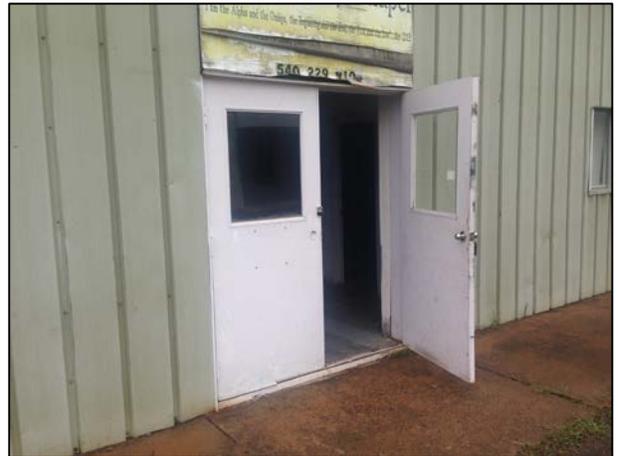
Typical Exterior Metal Door

The windows are aluminum sliding units, single glazed. The exterior doors are painted hollow metal. The hardware is not ADA compliant. There are steps at all exterior doors.

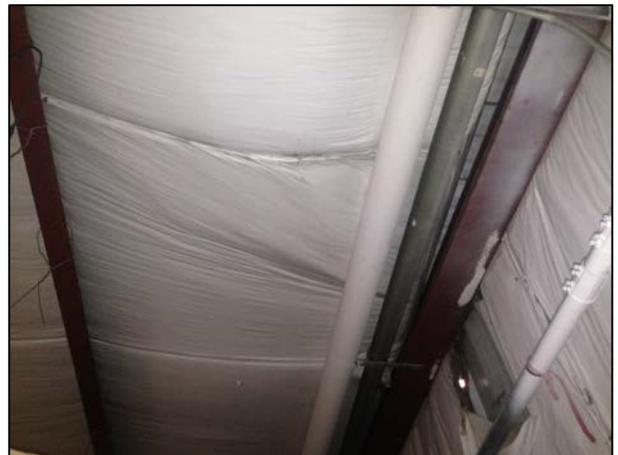
The exterior walls of Building B are prefinished metal panels on an exposed CMU block foundation. The building is insulated by batt insulation draped from the structural purlins. This insulation value is less than the minimums required by the current building code.

Typical Batt Insulation

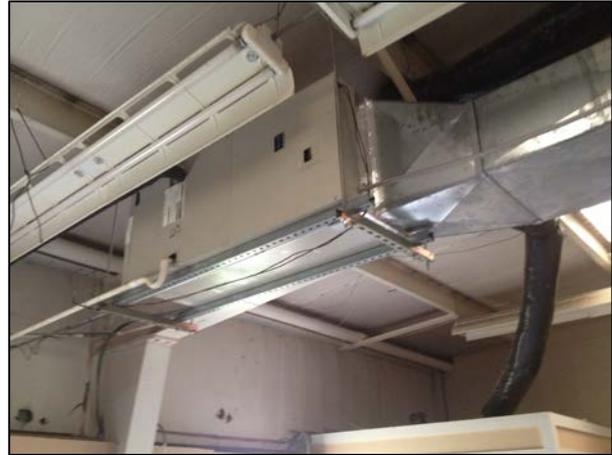
Two spaces of the building are cooled by split system refrigerant based fan coil units suspended from the roof structure above lay-in ceilings. These units use galvanized steel ducts and operate via wall mounted thermostats. These split systems were not functioning at the time of the visit, but the indoor units appeared in good condition and the outdoor condensing units appeared to be fair condition. No nameplate data was observed, but the two systems are likely four to five tons in size. The units have no outside air. The median life expectancy of air cooled split systems is 10 years. By appearance, these units are approaching the end of their useful life and should be replaced if the building is re-purposed.

Indoor Mechanical Unit

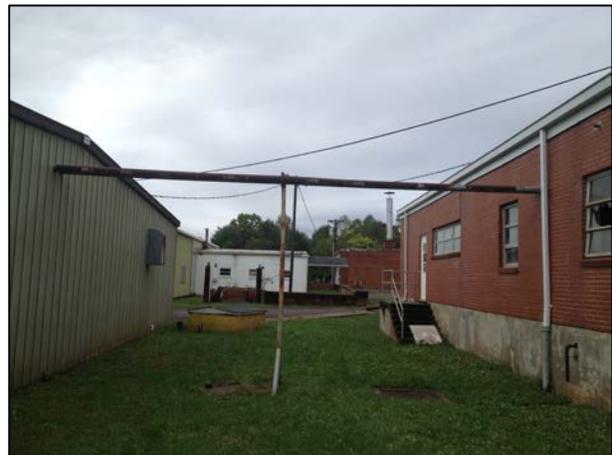
Due to the boiler being shut down in Building A causes Building B to have no heating. However, it was previously conditioned by heating water pumped from Building A (Automotive) prior to the boiler system being shut down. Heating water was pumped out of the bottom of the steam boiler and piped above grade to Building B. Heating inside Building B was provided by unit heaters suspended from the roof structure. The unit heaters are in poor to fair condition.

Piping Between Buildings A and B

Due to the boiler being shut down for at least two years, the piping has been left sitting empty which allows for accelerated corrosion to occur. It is likely that the interior of the piping is rusted beyond its useful life.

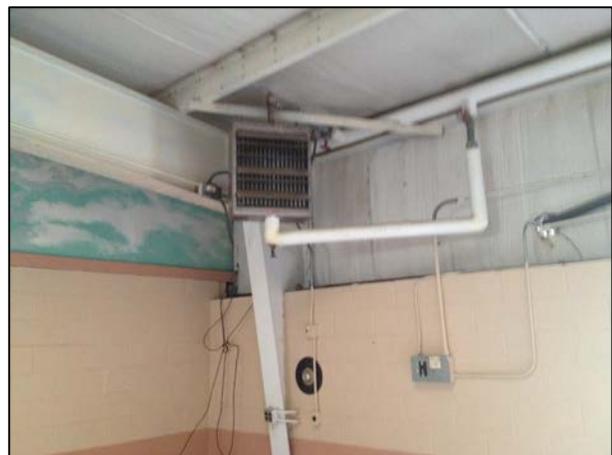
Unit Heater

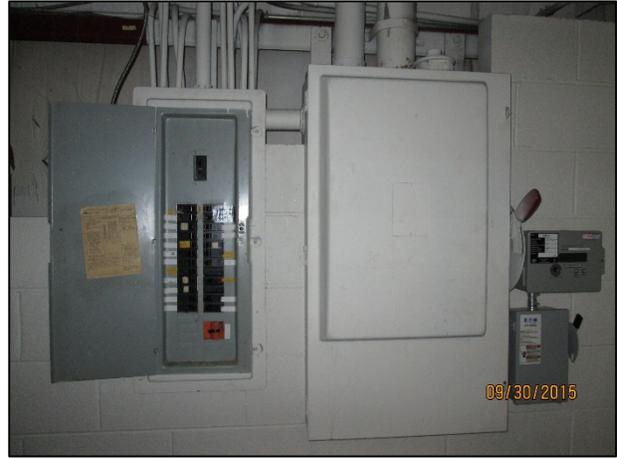
The main service to the building is 400A at 208/120V. The service originates at a utility pole to the south of the building, and is connected to a service mast on the south side of the structure with aerial triplex cable. The main service disconnect is an original 400A safety switch, and this switch serves 4 panels of various vintage throughout the building. All panels are beyond their useful life, and would need to be replaced if the building is to be re-purposed.

Main Service Disconnect

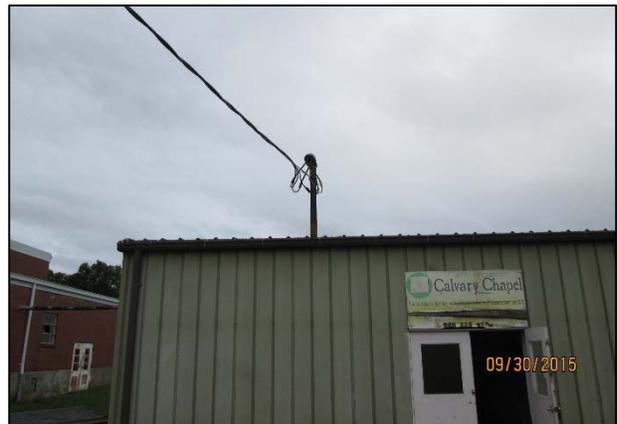
Service Drop

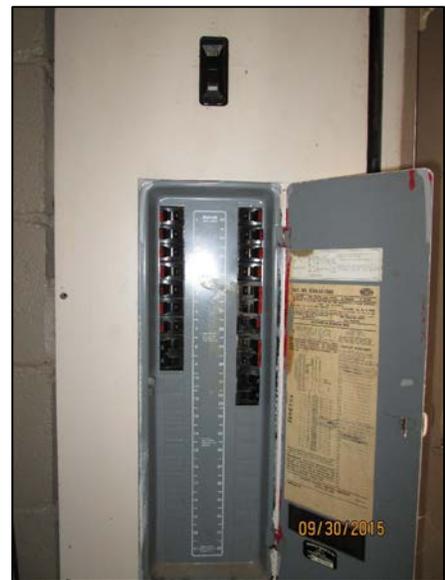
Obsolete Panel

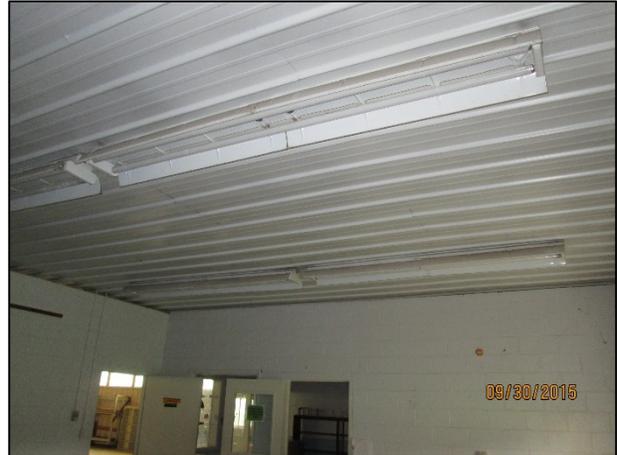
The building is equipped with 8' linear 2-tube T12 fluorescent fixtures, T12 lay-in fluorescent fixtures, and a few CFL recessed can fixtures. The majority of the fixtures are in poor condition and obsolete, and are no longer specified due to energy efficiency. It is unclear as to which of the fixtures work, and it is recommended to replace the entire lighting system in a remodeling project.

Fluorescent Fixtures

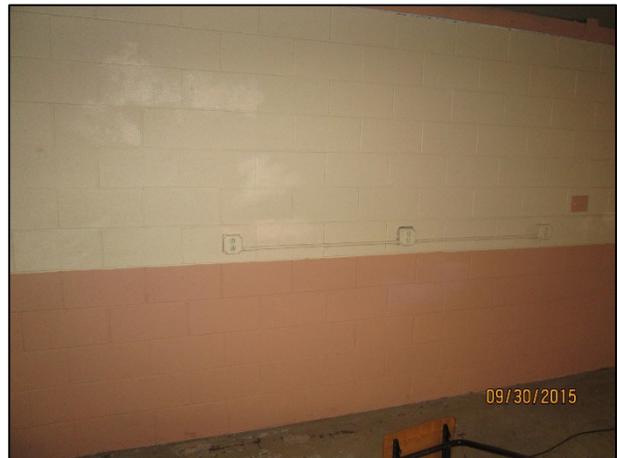
Wiring and wiring devices within the building appear to be largely original, and may be in working order, though this could not be confirmed during the survey. Any reconfiguration of the facility would require a great deal of modification to the systems and in light of their age, it is recommended that all wiring and devices be replaced.

Existing Wiring

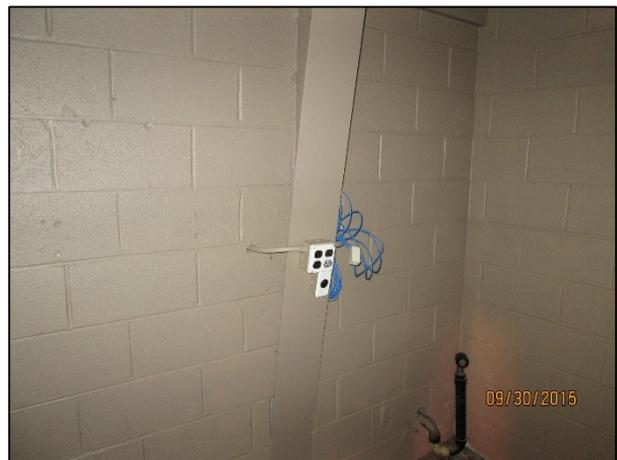
The building has an aerial telephone drop that connects to the south face of the structure. This service appears to be a small pair count, and is of original vintage. There is evidence of old data lines in the building, but they would have been DSL based. Data and telephone systems would need to be completely replaced in order to provide modern services to the facility.

Old Data Connection

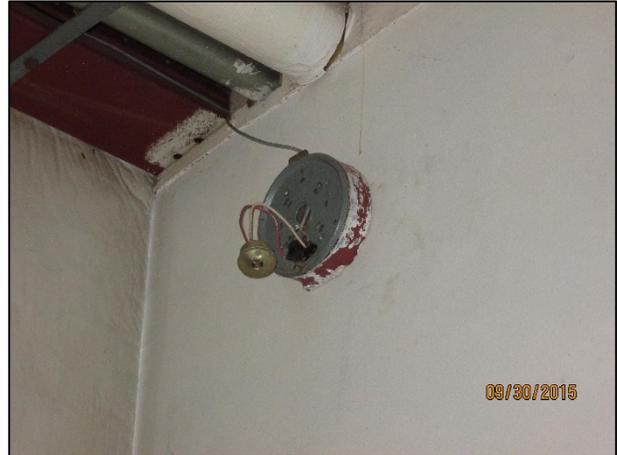
There is no working fire alarm system in the building. There is evidence of an old, non-working fire bell system in the facility.

Old Fire Bell

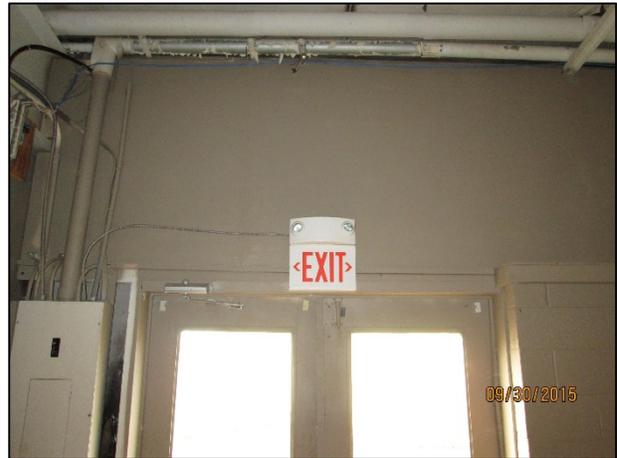
There are modern battery powered combination exit light / emergency light fixtures in the building in the correct locations. There is no exit discharge lighting installed.

Emergency Exit Sign

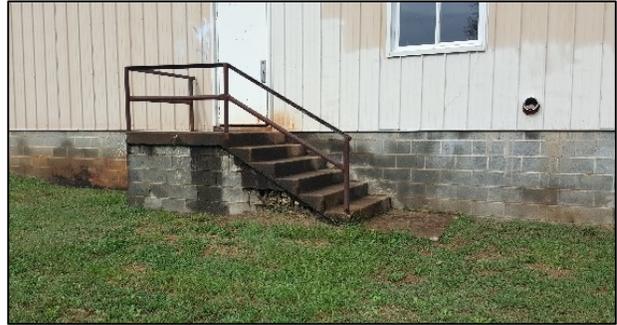
Masonry foundation walls appear sound. Water damage has been limited by a proper drip edge where the metal wall panel ends and a roof overhang. Exterior stairs are damaged and in need of repair.

Foundation Wall and Stair at the East Elevation

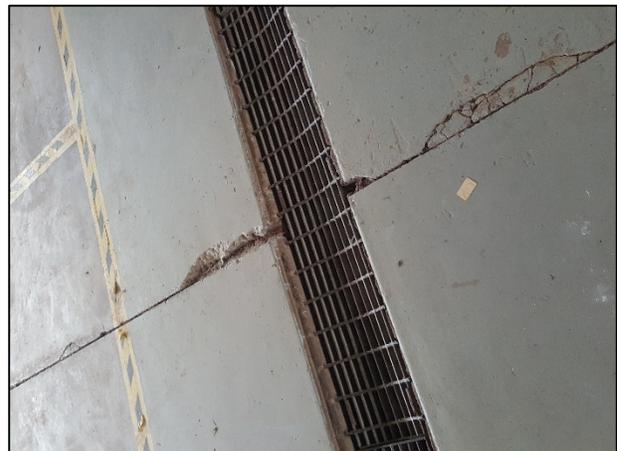
Floor slabs-on-grade are generally in good condition. Adequate control joints are present to control cracking. A trench drain down the center of the open work area appears in good condition, although the grate covering the drain requires replacement.

Trench Drain

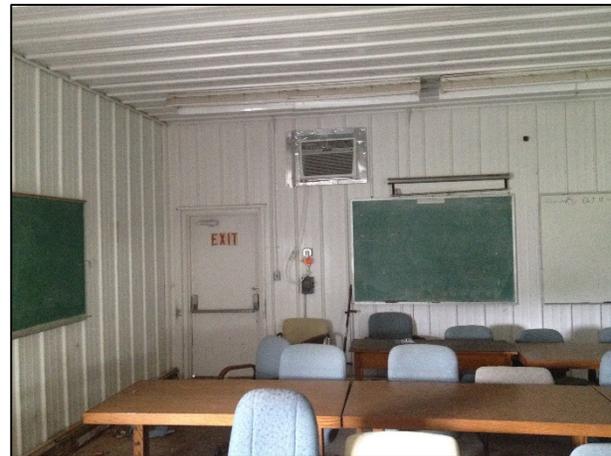
The classroom in the rear of the building uses a through the wall air conditioner, which is beyond its useful life. The classroom had a heating water wall convector but this has been damaged beyond repair.

Classroom Air Conditioner

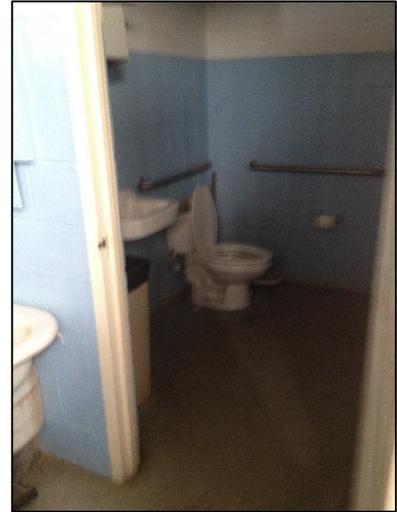
The building has two toilet rooms, each with a lavatory and toilet. The toilet is beyond its useful life. The lavatory appears to be functional and should be replaced. The electric water heater is beyond its useful life. During the field investigation, domestic cold water was available but there was not hot water.

Toilet Room

It is recommended that to re-purpose the building that all above grade plumbing fixtures be replaced.

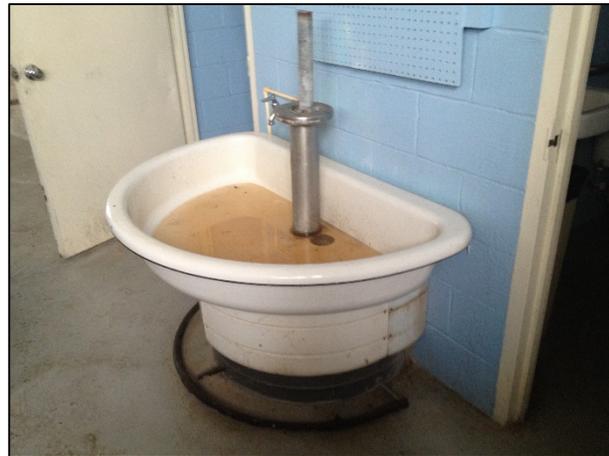
The group hand washing station is filled with water, indicating a clog. It is assumed that the clog is local to the station because no backflow was indicated at the toilet. However, if the building is re-purposed then the point of clog should be verified and repaired as required.

Hand Washing Station

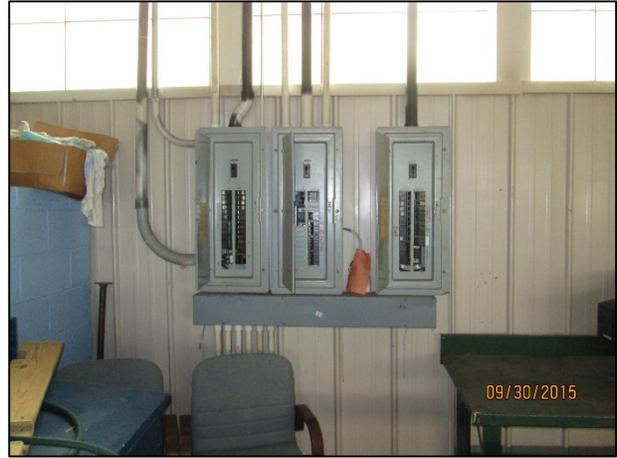
The main service to the building consists of 3-200A, 3 phase, main breaker-equipped panels at 208/120V. The service is underground, and connects at the utility meter on the west face of the building, back to back with the panels. The main service panels are original Murray panels in fair condition, and are obsolete. All service equipment is beyond its useful life, and would need to be replaced if the building is to be re-purposed.

Main Service Panels

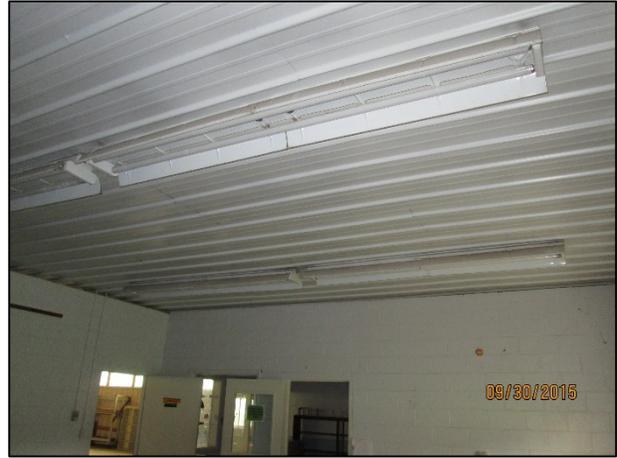
The building is equipped with 8' linear 2-tube T12 fluorescent fixtures, surface mounted. The majority of the fixtures are in good condition, though they are obsolete and are no longer specified due to energy efficiency. The fixtures do appear to be largely in working order, and could be used, though it is recommended to replace the entire lighting system in a remodeling project.

Fluorescent Lighting

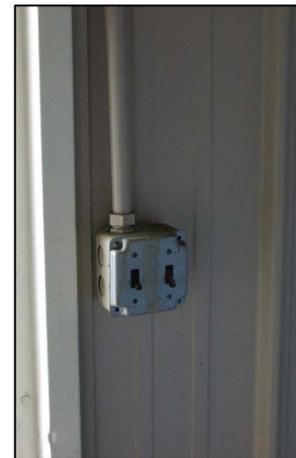
Wiring and wiring devices within the building appear to be largely original, and are likely in working order, though this could not be confirmed during the survey. Any reconfiguration of the facility would require a great deal of modification to the systems and in light of their age, it is recommended that all wiring and devices be replaced.

Typical Wiring

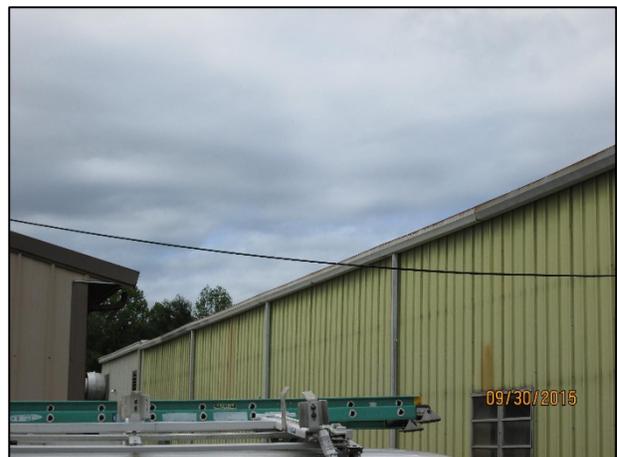
There is an existing telephone drop to the building, but there was no actively working communications equipment observed.

Telephone Drop

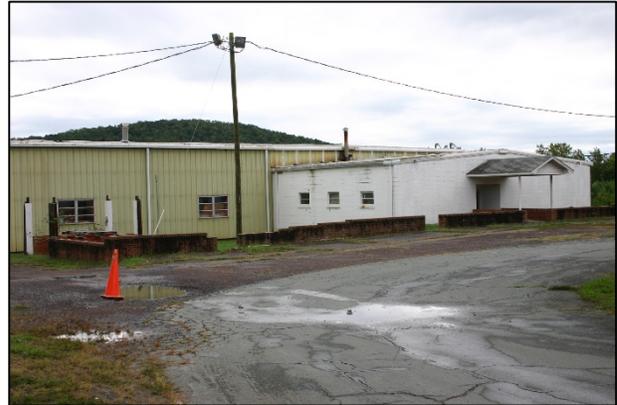
The window are aluminum sliding units, single glazed. The exterior doors are painted hollow metal. The hardware is not ADA compliant. There are steps at all exterior doors. Brick has been added to the stoop and steps at the west door, making the riser heights non-compliant with the building code.

Building D: West Elevation

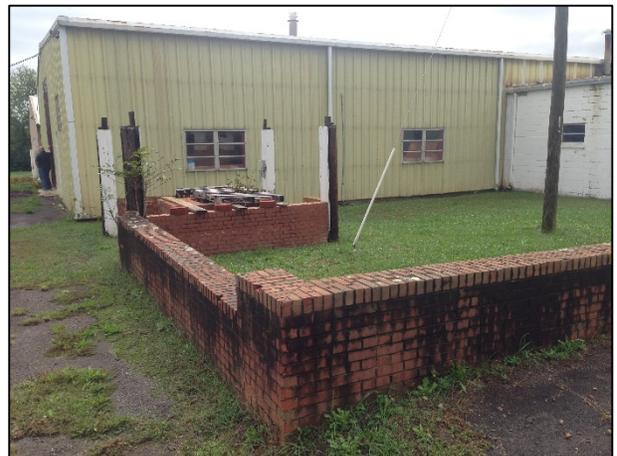
Building D Windows

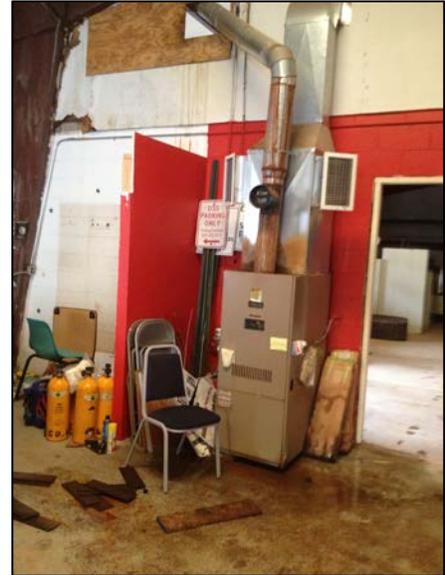
The main high bay (front of building) is heated with a ducted oil-fired furnace rated for 80 mbh. Test report paperwork associated with the unit show test reports dating as back as February 2000. The furnace operates via wall mounted thermostat. The gas flue is routed up the wall and through the roof, adjacent to exposed plywood upper wall, and this is likely a code violation for failure to maintain clearance to combustibles.

Furnace

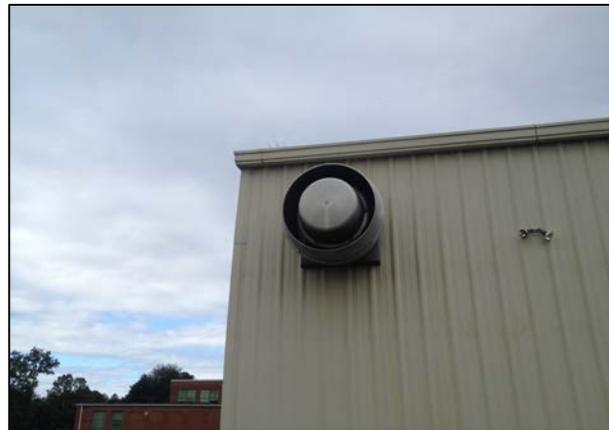
Propeller Wall Fan

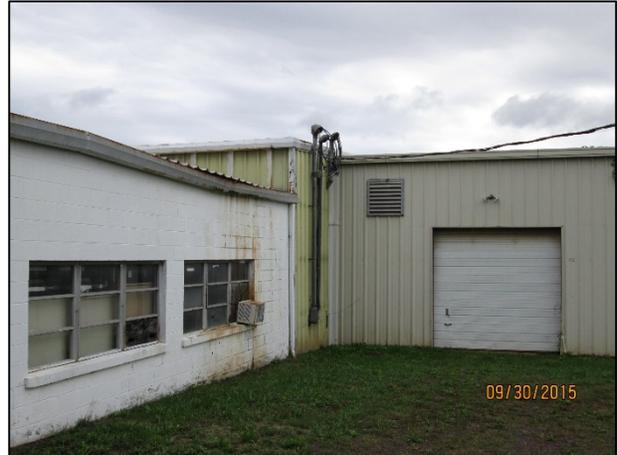
Aerial Service

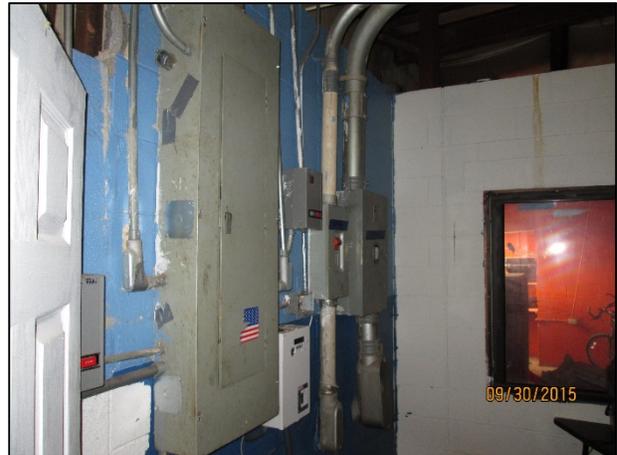
The building is served at 208/120V from an aerial drop on the south side of the structure. The main disconnecting means consists of one 400A main breaker-equipped panel, one 400A disconnect switch (presently out of service), and one disconnect switch of undetermined rating. All distribution equipment is in poor condition, and is past its useful service life.

Main Service Equipment

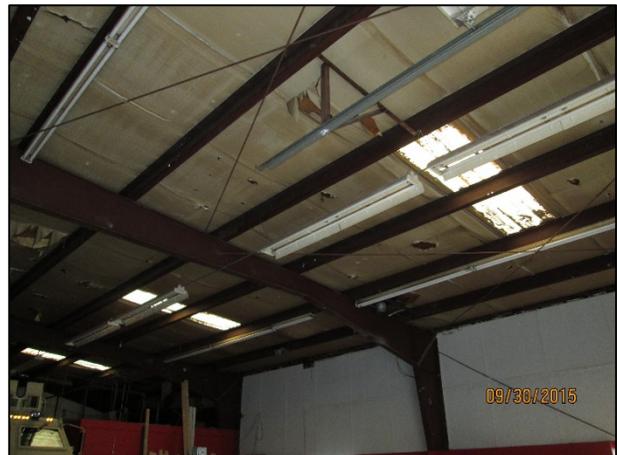
The building is primarily equipped with 8' linear T12 fluorescent fixtures mounted from conduit at ceiling height. There is a mixture of open strip fixtures and reflector fixtures. The reflector fixtures appear to be in good condition, though fixtures are mismatched throughout the front high bay area. All of the installed fixtures are obsolete.

Fluorescent Lighting

The lighting in this building should be replaced in conjunction with any remodeling activity.

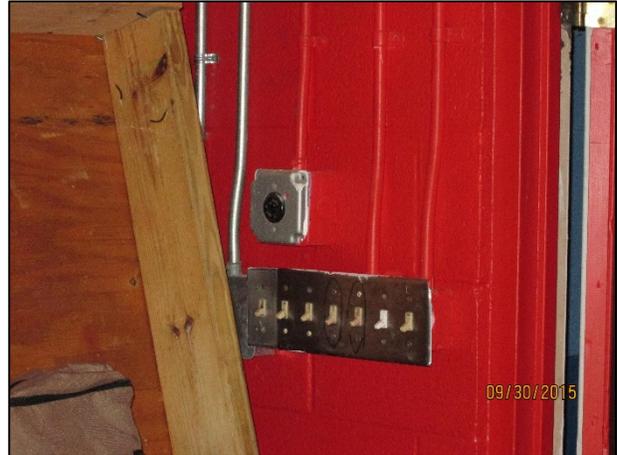
The wiring and devices throughout the building are a mix of original and older additions. The condition ranges from good to poor, though none of the current systems would be likely to support any changes in building program.

Typical Wiring

It is recommended that the building be rewired in conjunction with any remodeling efforts.

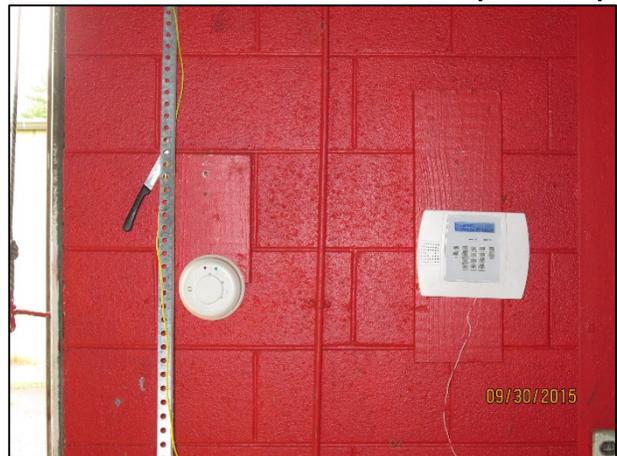
The building is equipped with a modern residential-grade Honeywell security system which includes smoke detectors, door switches, and motion sensors. It is connected to a monitored telephone line.

Honeywell Security System

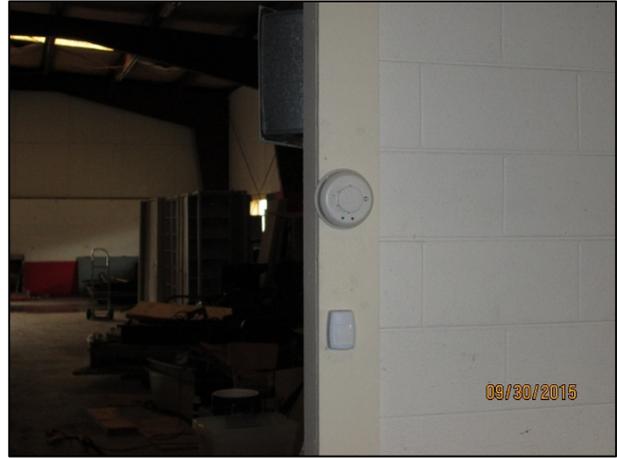
Fire and Security Sensors

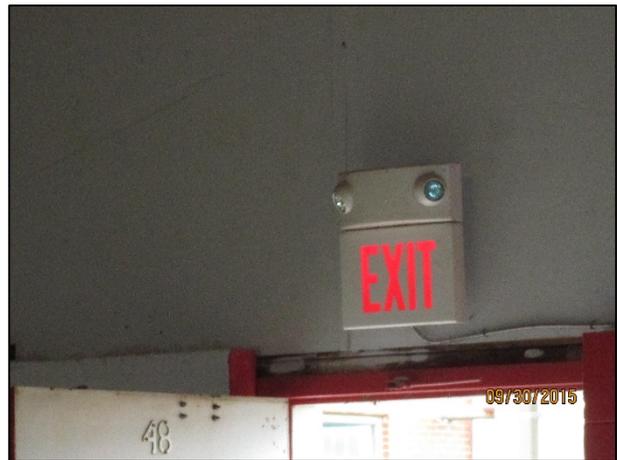
The building is equipped with modern battery powered combination exit / emergency lighting units, located properly.

Emergency Exit Sign
