CARVER-PIEDMONT AGRICULTURAL INSTITUTE FACILITY ASSESSMENT

SPECTRUM DESIGN P.C.
Plaza Suite 1
10 Church Avenue SE
Roanoke, VA 24011-2104
540.342.6001 PH | 540.342.6055 FAX
www.spectrumpc.com

DECEMBER 10, 2015
PROJECT NO. 15054

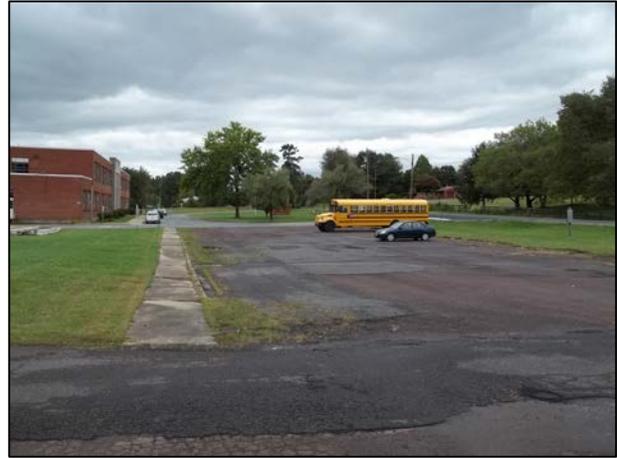
Parking lots appear to have been paved at a different time than the main roadways. While the aggregate and hue of the pavement is different, the asphalt appears usable, but does require maintenance in the way of edge repair and restriping.

Main Parking Lot

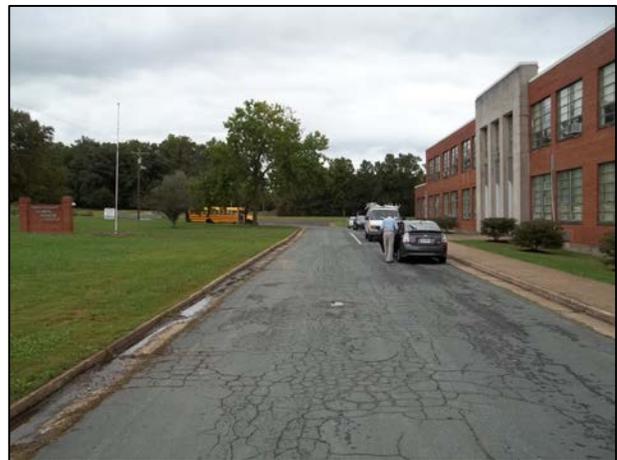
Parallel Parking at Front Entrance

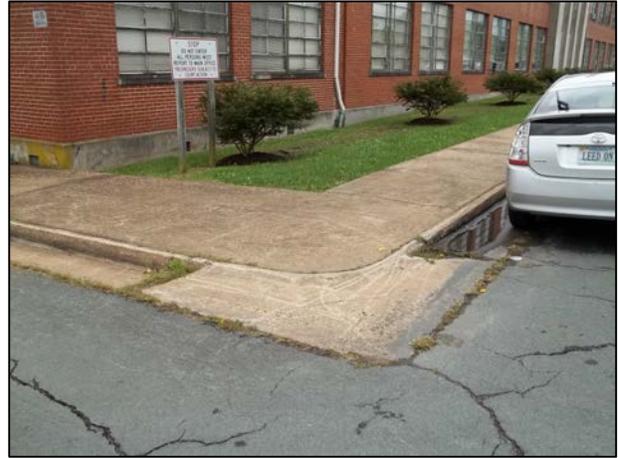
Handicapped parking does not meet current codes with respect to proximity, slopes and surfaces. Modification of the existing spaces to comply would be required should their current locations be maintained. The addition of a new parking area closer to the front door for visitor and handicapped parking is possible within the front lawn. Development of a new parking area would recommend 4 new handicapped spaces and 5 visitor spaces and cover an area approximately 45 feet in length by 60 feet in width. Depending upon the need for parking closer to the front doors, two of the above noted lots could be installed flanking either side of the flag pole and yield 4 handicapped and 15 new parking spaces total. Handicapped accessibility to at least one entry to all buildings was observed, however signage and markings were not present.

Handicap Access

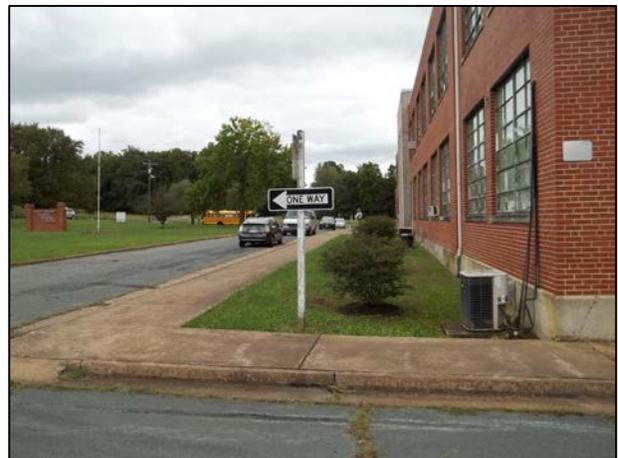
Front lawn (between the sidewalk and main building face): Lawn slopes down and towards the building. This is caused by the elevation of the sidewalk being approximately 12" above the grade at the building face. Soil backfill is needed across the front of the main building's entire frontage to force drainage back to the sidewalk and pavement. This will require coordination with several mechanical units and displacement of landscaping.

Drainage at Front

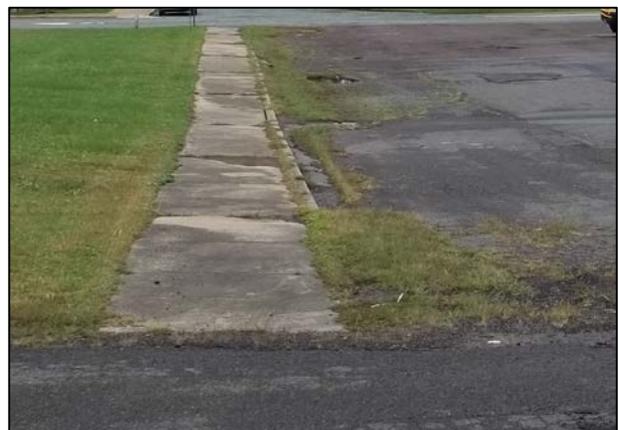
Front left parking lot (Handicapped Spaces): Sediment build up and edge conditions along the curb face are causing water to pond. General lot maintenance may improve this condition.

Sediment Build up in Parking

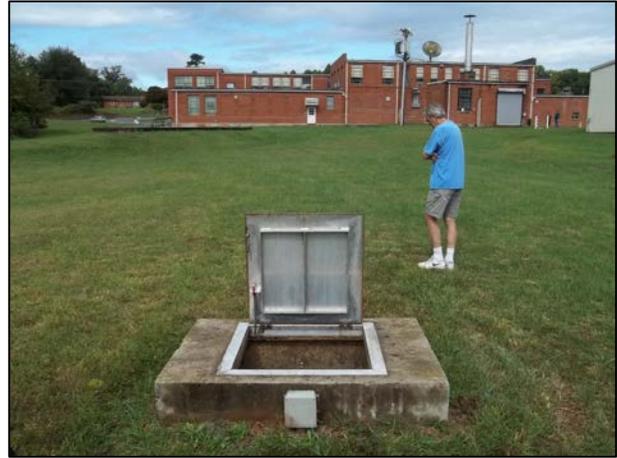
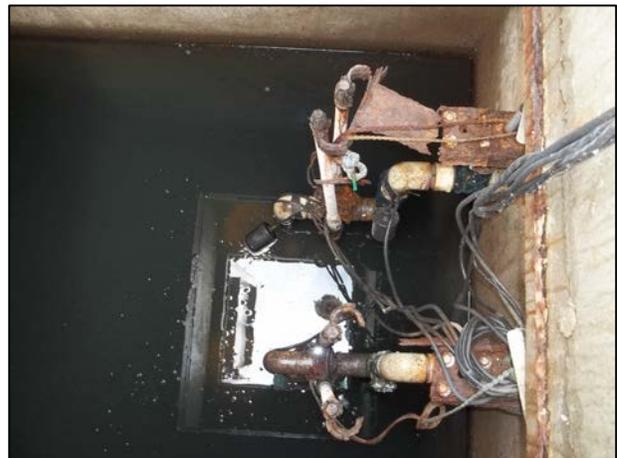
Sanitary Sewer: The buildings have separate piped laterals that combine and discharge to a duplex pumping station in the field to the rear of the property. The pump station concrete structure is in good shape, but the working components within are beyond end of life. Replacement of the pumps and guiderail systems are needed immediately. Matching pump sizes without need for redesign is possible and should be locally available. The electronic supervision (floats) were operable and do actuate one of the pumps. The controller for the station was not found, so it was not determined if the pumps work in alternating fashion or if the second pump is for high flow. Controls can be checked for proper function at the same time the pumps and rails are replaced.

Sewer Pumps

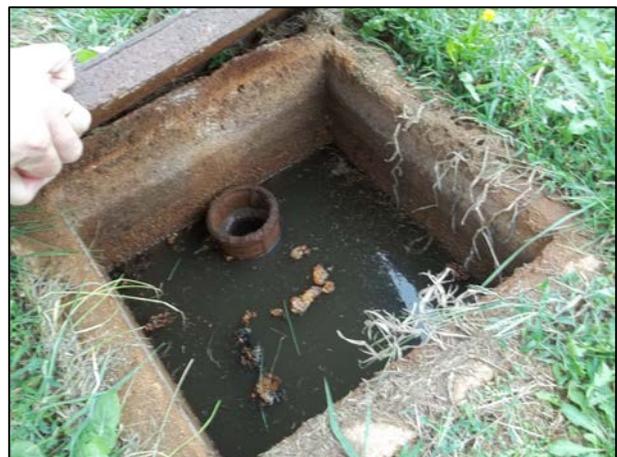
Grease Interceptor: Just east of the main building is a small concrete square with a steel (loose) lid. This appears to be the original grease trap serving the kitchen. The trap is non-functioning. A large concrete vault downstream of the small trap appears to be a large septic tank. The top of this vault was not accessible on the date of inspection, but appears to be oversized for the current use.

Grease Interceptor

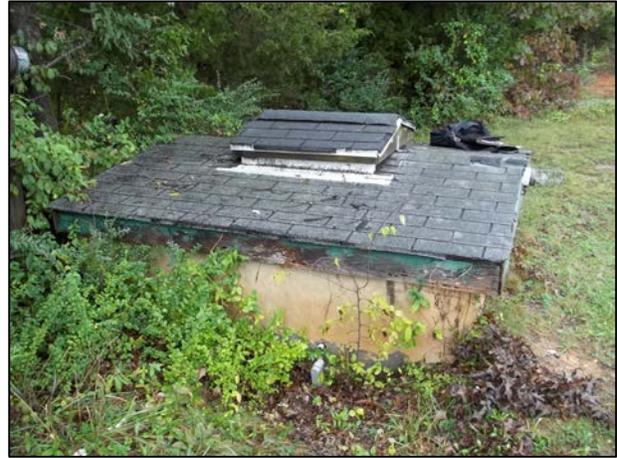
The property is currently served by a well system located at the front (southwest) corner of the site. The well house is deteriorated and moisture/humidity have caused the well head, pressure tank, and piping to be rendered useless for overhaul. Damage caused to the well head in removing the pertinent pieces will risk losing the ability to even test the well. In addition, power lines placed directly over head of the well house now prevent drilling rig equipment to set up over the well head for testing or future maintenance. The well is currently operational, however the water produced is not potable due to pH and iron. Previously the water was being treated for alkalinity and iron, but these features have since been uninstalled. It is possible that the system can be sustained for minimal use (toilet flushing and mechanical needs) but its continued use will ultimately deteriorate the building piping and any fixtures or equipment it comes in contact with over periods of time. It is recommended that the existing well system be abandoned and a new well be drilled to serve the facility.

Well House

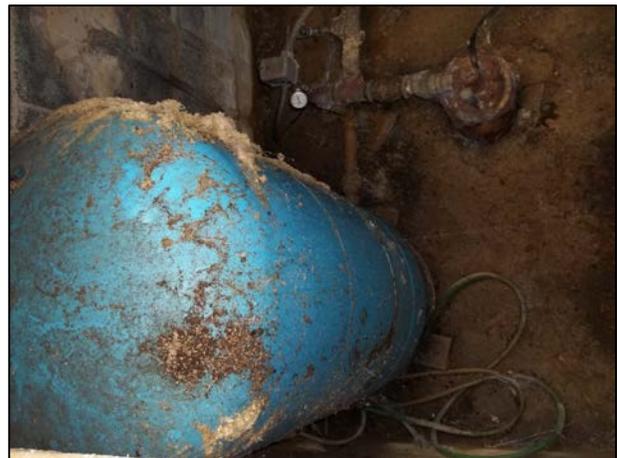
Well Head

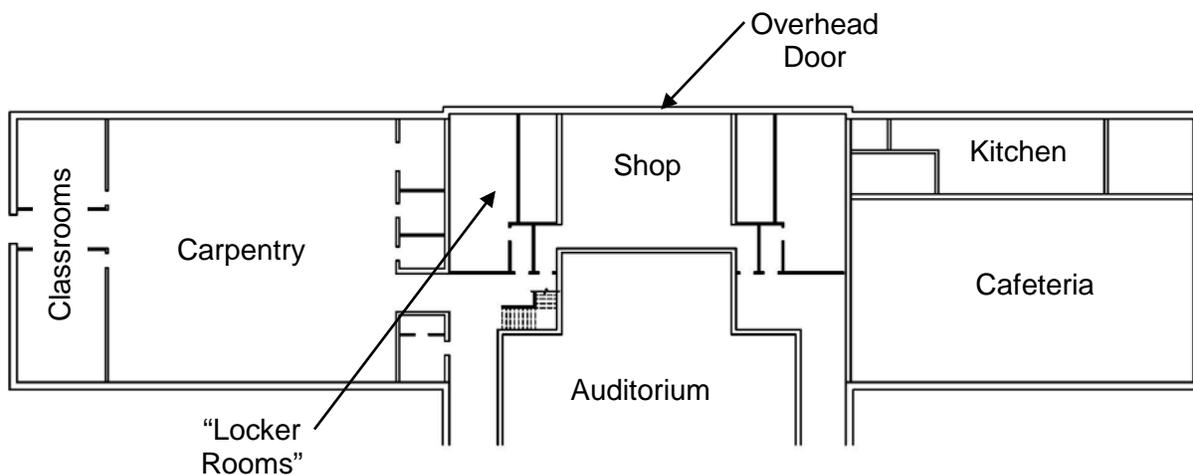
Main Building Rear Wing Floor Plan

The shop area at the rear of the building would be the suggested location for a commercial kitchen because of its high ceilings and large volume. The large open area in the center of the rear wing can be used for support spaces and the large overhead doors make it ideal for loading and unloading.
